Site Summary Group R
AREA IV
Santa Susana Field Laboratory, CA

Site Summary – Building 4011

Site Summary Group S
AREA IV
Santa Susana Field Laboratory, CA

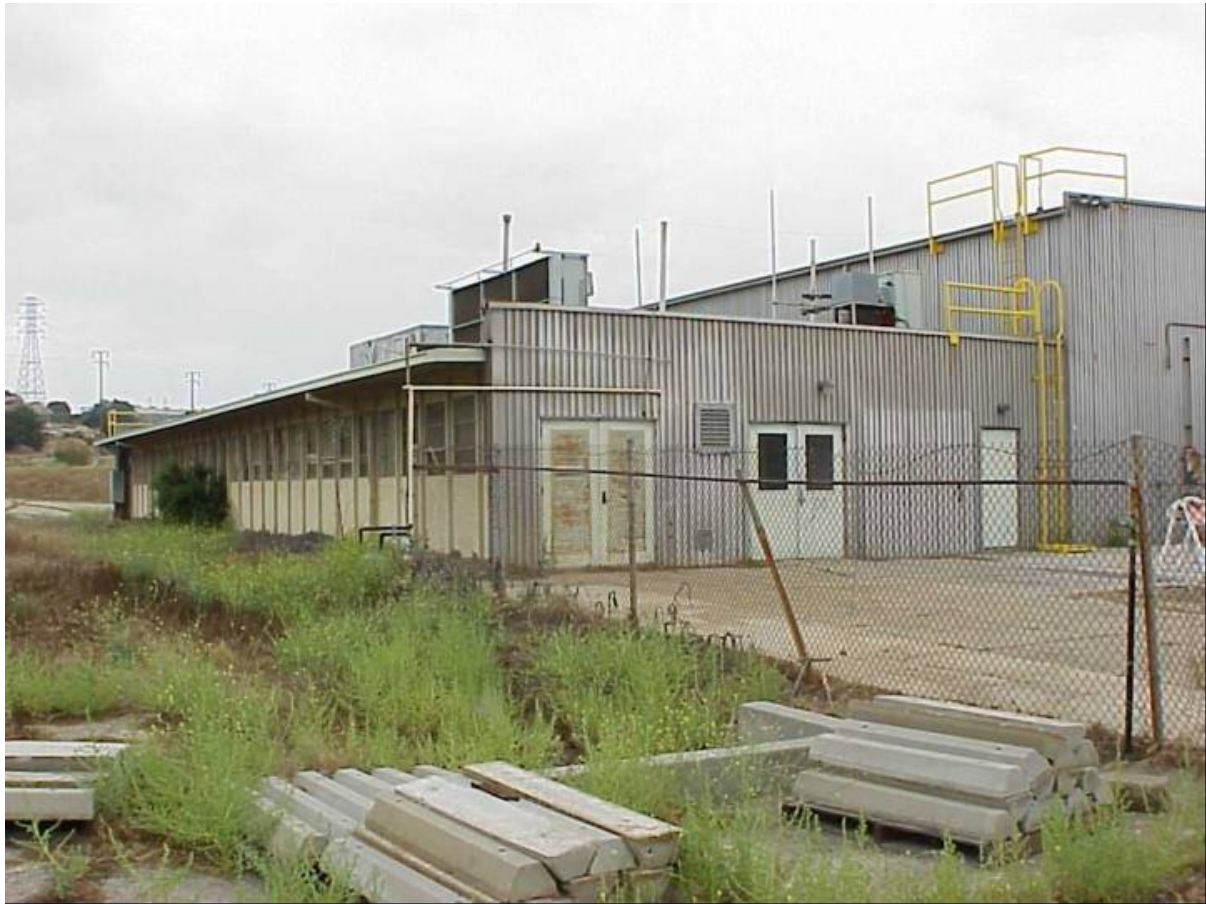
Photograph – Building 4011

- Building 4011 is a 15,120-square-foot building that was constructed out of steel.¹
- Building 4011 had an associated leachfield. The leachfield was removed in 2000.²
- Serviced by Substation 4711.
- Serviced by Traffic Dispatch Building 4403.

- DHS released the facility for unrestricted use December 16, 1998.⁶
- Building 4011 is currently used to house communications equipment for Area IV.

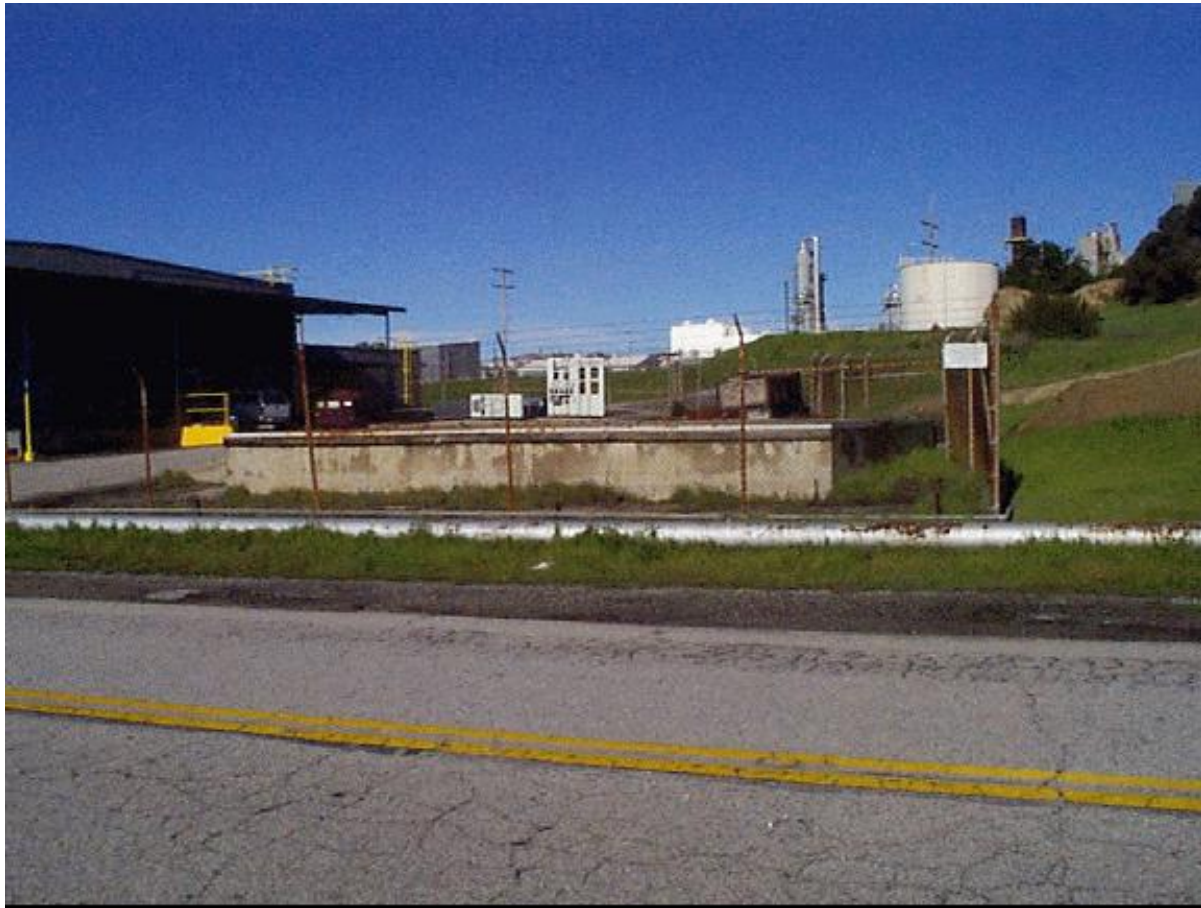
Photograph – Building 4500

- Building 4500 was a small shed built on a concrete pad.²

- The walls and foundation of Building 4500 are still in place.

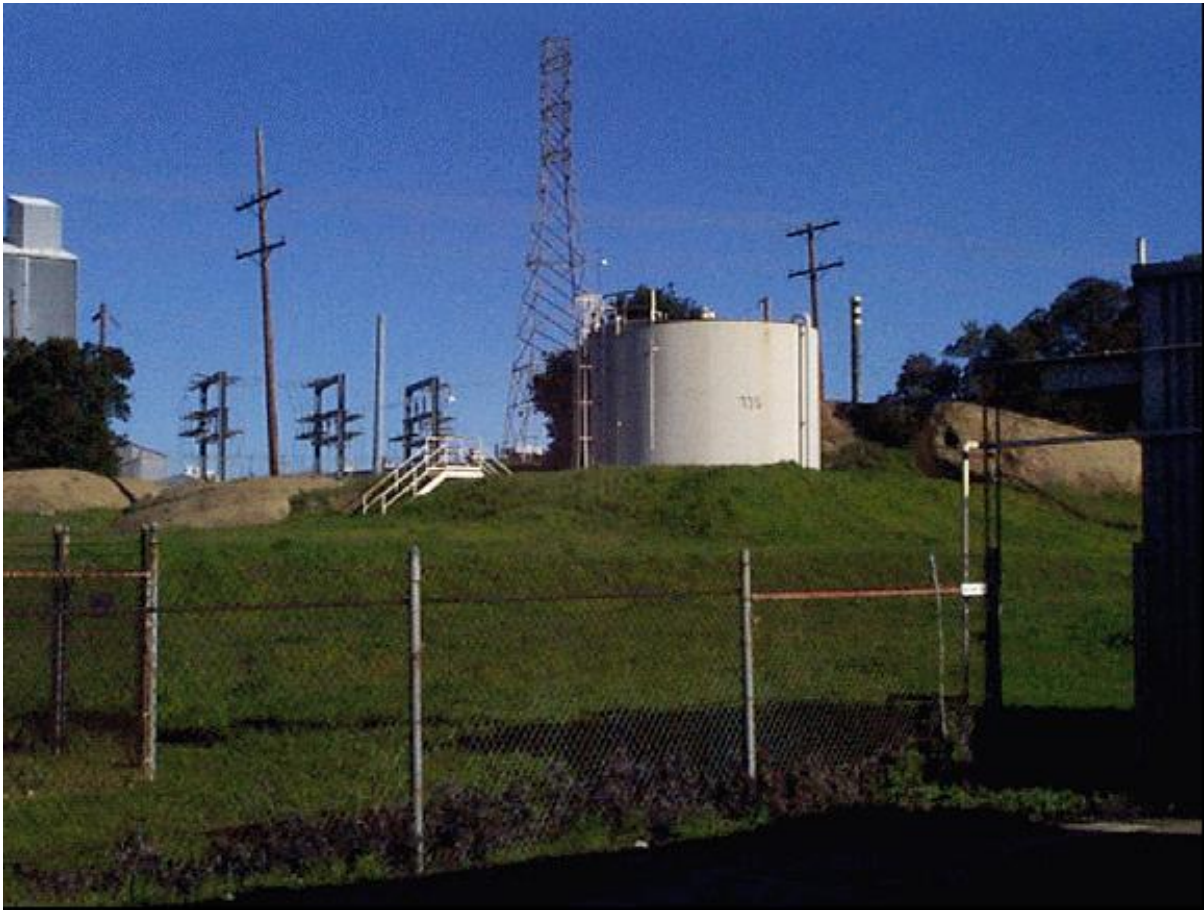
Photograph – Fuel Tank 4735

- Fuel Tank 4735 had a capacity of 86,000 gallons, was 26 feet in diameter and 24 feet tall. It was an above-ground vented structure constructed of carbon steel. A pump station was adjacent to the tank, and it contained a concrete pad with two pumps. The area was fenced.¹

- The Fuel Tank Farm and associated piping was demolished in 1999.

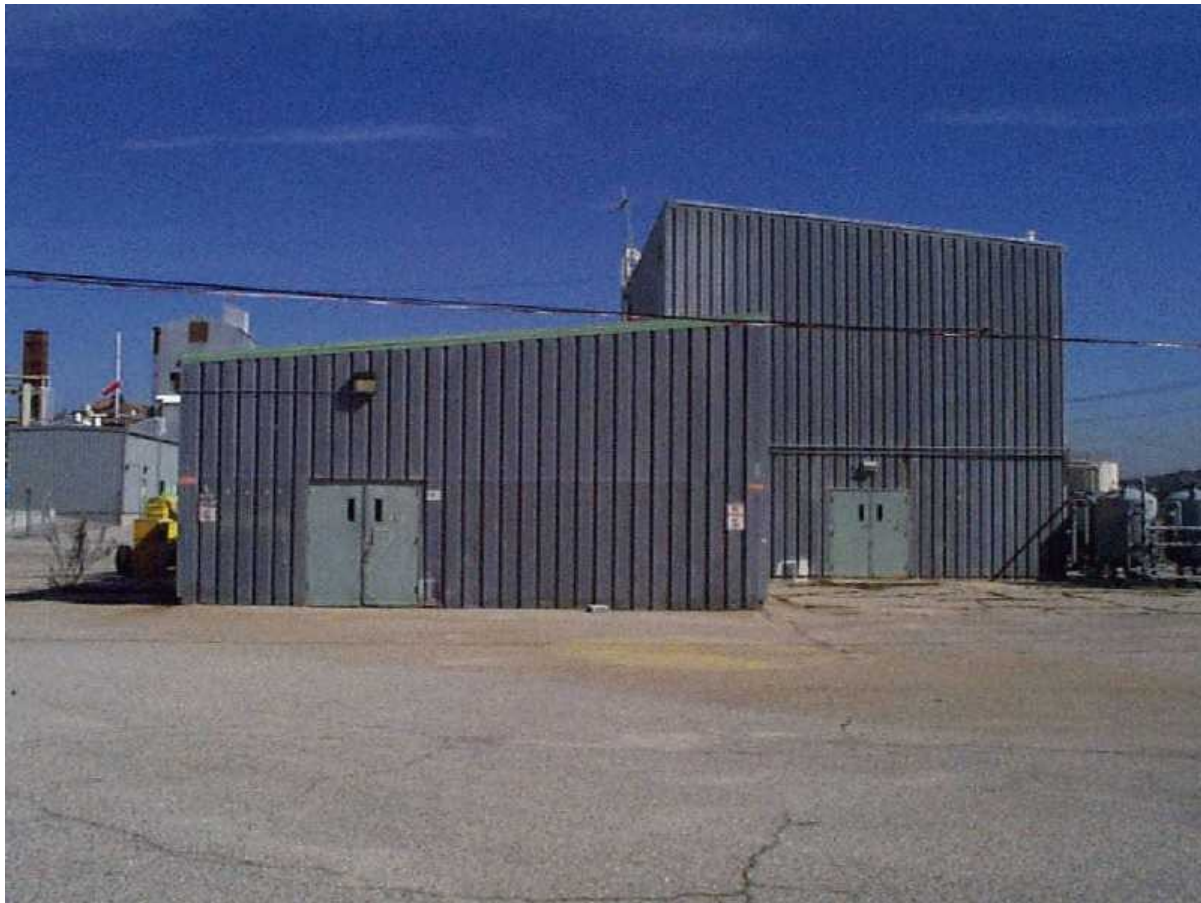
Photograph – Building 4062

- Building 4062 was a metal building consisting of a low bay and a high bay.
 - The support structure for the low bay was steel beams with corrugated steel siding and roof with concrete slab floor and concrete foundation.
 - The high bay was located over a concrete basement with a steel beam and plate floor at ground level. The support structure was steel beams with corrugated steel siding and roof. The building contained several internal partition walls with wood framing and drywall surfaces.¹
- Serviced by Substation 4762.
